Manhole Inspection Summary

Manhole # S35S__018MH

Insp Date: **3/24/09 10:07 AM**

Location Address: **1227 S HANOVER ST**

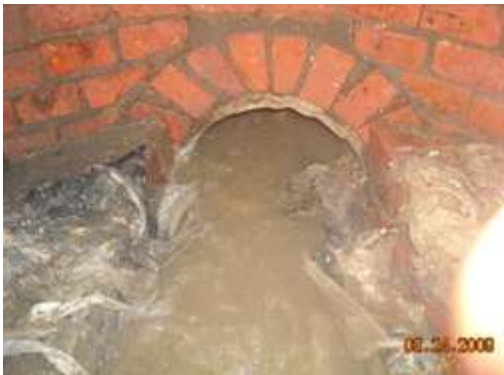
Defect 4

Condition: ☐ Sound ☐ Cracked ☐ Root Intrusion ☐ Deteriorated ☐ Leaks ☒ **Debris**

☒ **Evidence Of Surcharge** Depth: **0** (ft.) ☐ Active Surcharge Present

BENCH AND CHANNEL DEBRIS,
SURCHARGE EVIDENCE

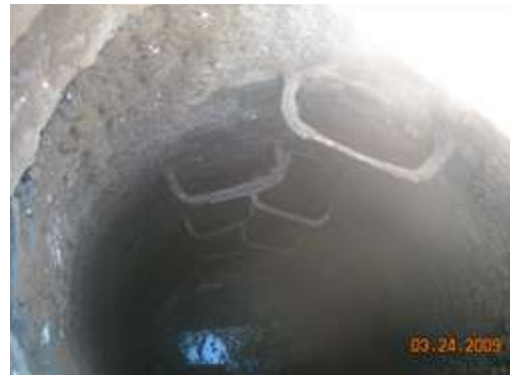
Defect 3

Condition: ☐ Sound ☐ Cracked ☐ Root Intrusion ☐ Loose Brick ☒ **Deteriorated**

Infiltration: ☐ None ☒ **Joint** ☐ Cracks ☐ Mortar ☐ Roots ☐ Wall

Count: **8** Missing: **0** ☒ **Corroded**

CORRODED STEPS, CHIMNEY
DETERIORATING, JOINT
INFILTRATION

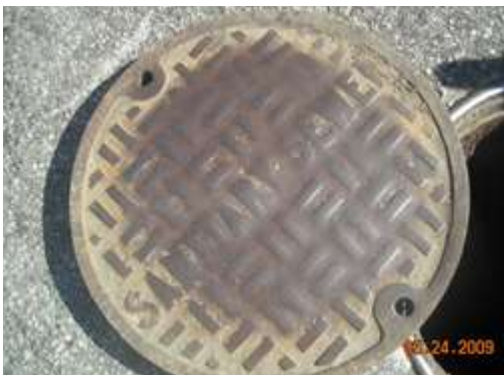
Defect 2

Condition: **Worn**

COVER WORN

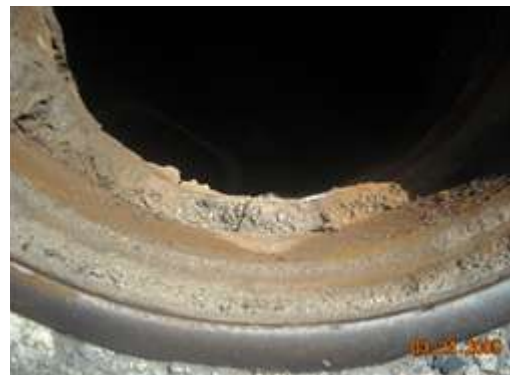
Defect 1

Offset: **2** (in.)

FRAME OFFSET

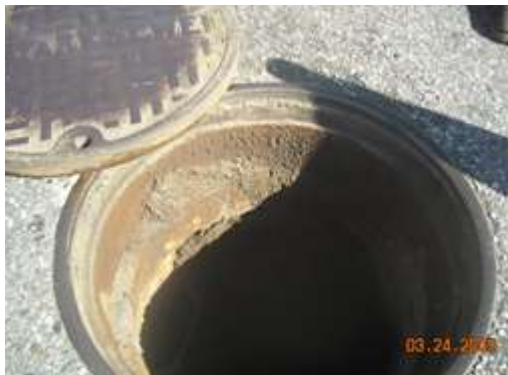
Defect 5

INFLOW EVIDENCE FROM SHEETING

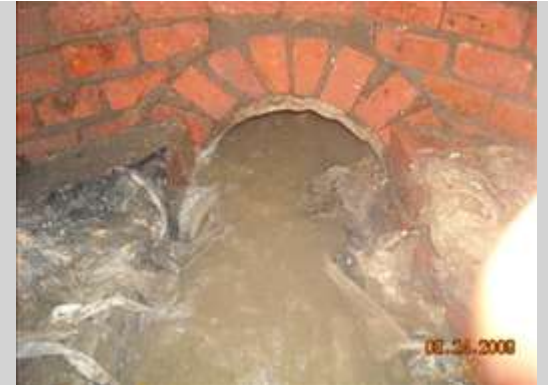
12 O'Clock Outflow

Pipe Height: **12** (in.) Rod and Bar (Angled)
Pipe Material: **Clay** ☐ Pipe Lined
Invert Depth: **13.90** (ft.) Flow Characteristics: **Fast**
Deposits: ☐ None ☐ Mud ☒ Sludge ☒ Debris ☒ Grease
Silt Depth: **4** (in.) Deposits Extent: **Medium**
Infiltration: **None** Pipe Seal Cond: **Sound**

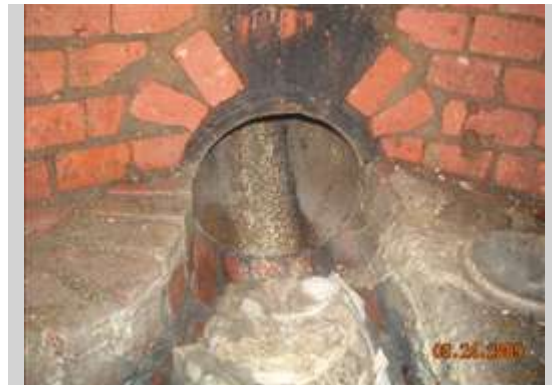
Drop In @ 3 O'Clock

Drop: **Outside** Rod and Bar
Angled: **Yes** Reading: **12.10** (ft.)
Inv Depth: **13.10** (ft.)
Drop Condition: **Partly Clogged**

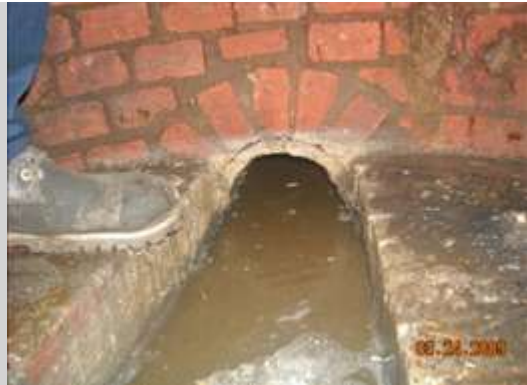
6 O'Clock Inflow

Deposits: ☐ None ☐ Mud ☐ Sludge ☐ Debris ☒ **Grease**

Silt Depth: **2** (in.) Deposits Extent: **Medium**
